IMS Characterization of Materials and Microstructure through Metallography, Imagery Analysis, and Mechanical Testing – Fundamental and Applied Studies

Surface Hardness Testing of Mobile Launcher 1 (ML-1) Vehicle Support Posts (VSP) Following Artemis I Launch Exposure

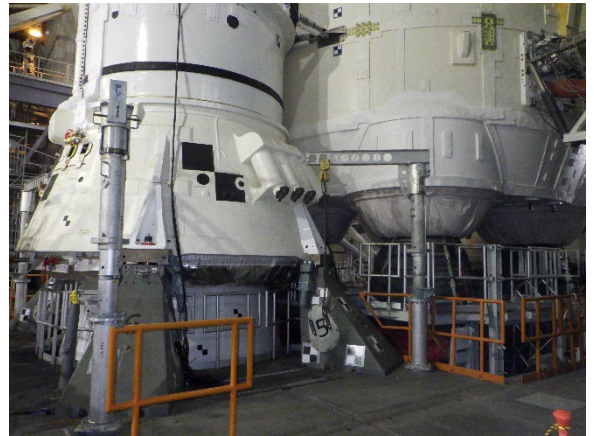
Fig 2. Mobile Launcher 1 Zero Deck Showing VSPs

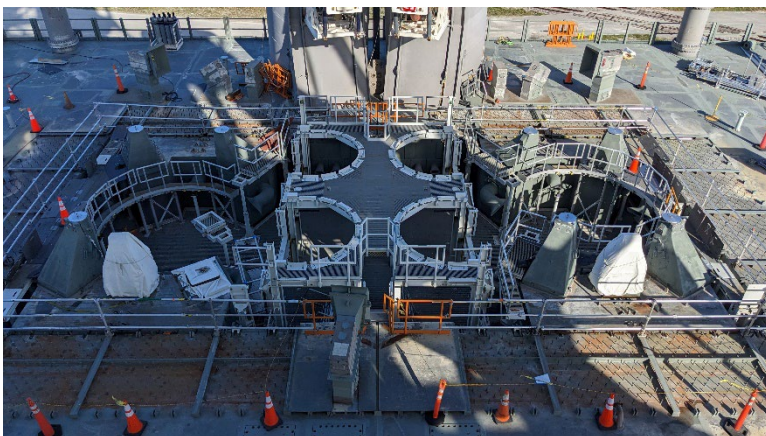
Initial hardness measurements were made at two interior surfaces of VSPs near the strain gauges and the corresponding exterior surfaces (engine hole-facing). Field hardness measurements on the exterior, engine hole surface-facing surfaces for all eight VSPs ranged from 175 to 226 HB/P, well below the minimum hardness of 302 Brinell (HB). Opposing interior surface hardness measurements near strain gauges ranged from 264 to 358 HB/P. In all cases for flight VSPs, a drop in interior-to-exterior hardness ranging from 70 to 132 HB/P was measured.

Fig 3. Zero Deck Showing 7 VSPs Post Artemis I Launch

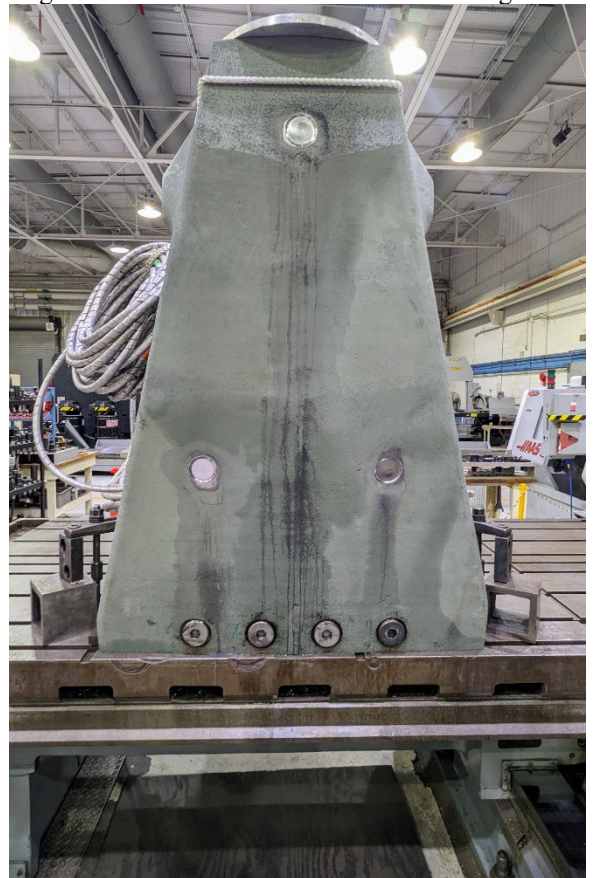
To determine the degree of softening, 1/8” of material was machined away at three exterior surfaces of engine hole-facing side (Fig. 4). A significant increase in surface hardness was measured ranging from 50 to 86 HB/P. Values at these three locations were still slightly below the required minimum hardness, so an additional 1/8” material was machined away, and hardness values were retaken. At the 1/4” depth, hardness values increased to 321 to 324 HB/P. These values fall above the required minimum, concluding surface hardness testing.

Fig 4. VSP #3 Removed for Machining

Rationale for VSP continued use was reached with no restrictions during a Chief Engineering Review based on hardness values exceeding minimum at critical locations and subsurface locations for VSP #3.
